The REMR Bulletin

Volume 11, Number 3

October 1994

Performance of relief wells during the Great Flood of 1993

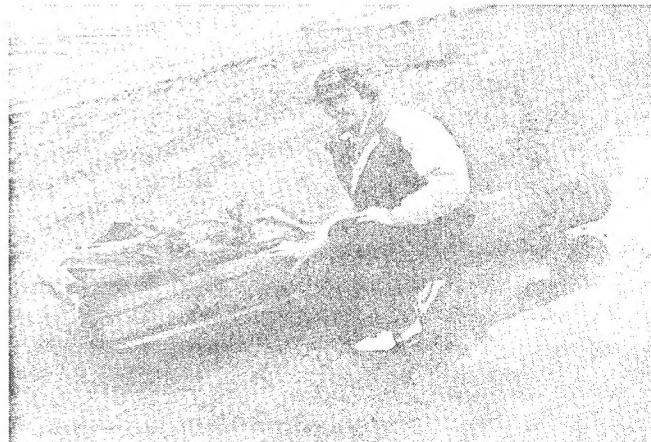
Figure 1. Portion of relief well riser exhumed by levee breach in Bois Brule levee in Missouri
